**RE: Great Basin Trucking Voluntary Cleanup Site Lot 1 (VCP #C044)  
2334 South 4000 West, West Valley City, Salt Lake County, Utah**

## **CERTIFICATE OF COMPLETION**

**SITE MANAGEMENT PLAN – REVISION 2  
ARIZONA TILE FACILITY  
VOLUNTARY CLEANUP PROGRAM  
ASSISTANCE ID No. CO44 LOT 1  
WEST VALLEY CITY, UTAH**

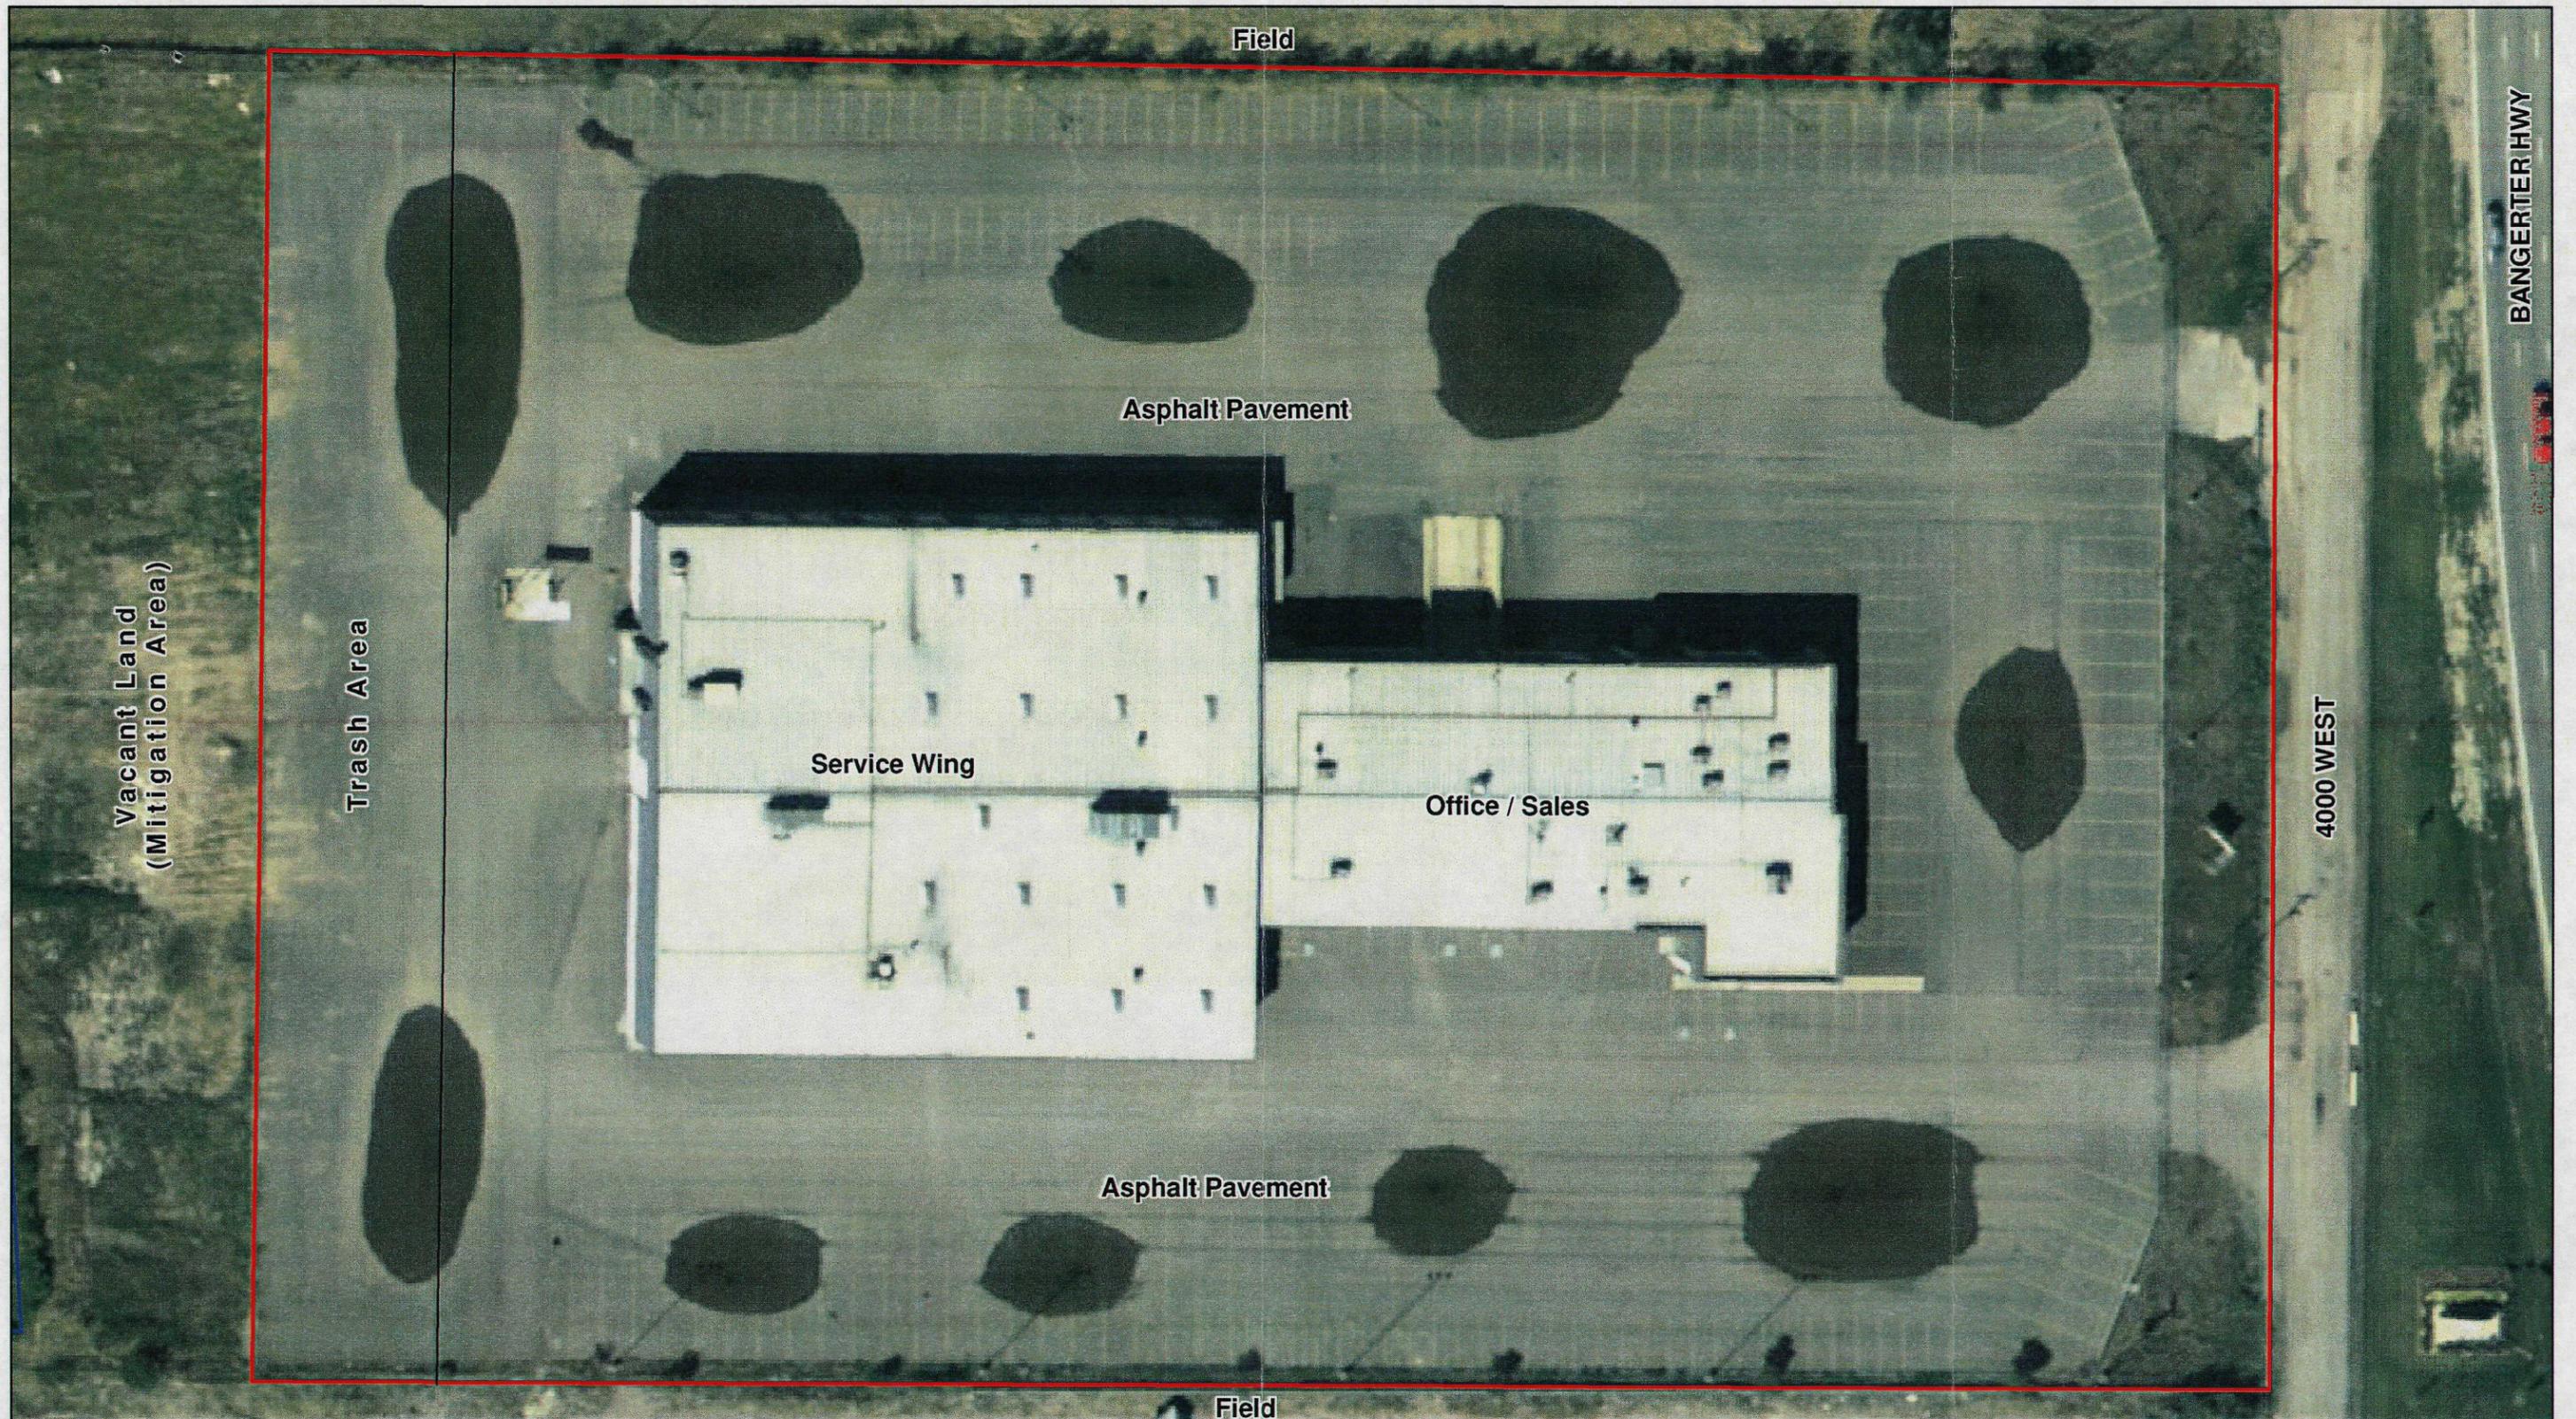
FIGURE NO: 2

FORMER GREAT BASIN TRUCKS FACILITY. APPROXIMATELY 2300 SOUTH 4000 WEST WEST VALLEY CITY, UTAH

AERIAL PHOTOS PROVIDED BY USGS. DATE: 9/18/2003. <http://terraserver.microsoft.com/>

SITE MAP

The Executive Director of Utah Department of Environmental Quality, through his undersigned designee below, has determined that Volvo Commercial Finance LLC The Americas, hereinafter collectively referred to as "Applicant", has completed a Utah Department of Environmental Quality (UDEQ) supervised voluntary cleanup of the real property described in Attachment A (the "Property" or the "Site"), in accordance with sections 19-8-108 and 19-8-110 of the Utah Code Annotated and the Voluntary Cleanup Agreement entered into on November 30, 2005, and that the Applicant is granted this Certificate of Completion ("COC") pursuant to section 19-8-111, subject to the conditions set forth in section three below. A figure depicting the site is included in the Site Management Plan, Attachment B, Figure 2.

The Site comprises approximately 8.0238 acres, is located at approximately 2300 South 4000 West in West Valley City, Utah. Figures 1 and 2 depict the property boundaries and relevant features of the site.
